**Flood Control Project Maintenance
Levee Inspections**

2016 Channel Summary Report

San Joaquin County Flood Control and Water Conservation District

Flood Control Project Maintenance**Unit Cover Sheet****2016 Channel Inspection Results****San Joaquin County Flood Control and Water Conservation District**

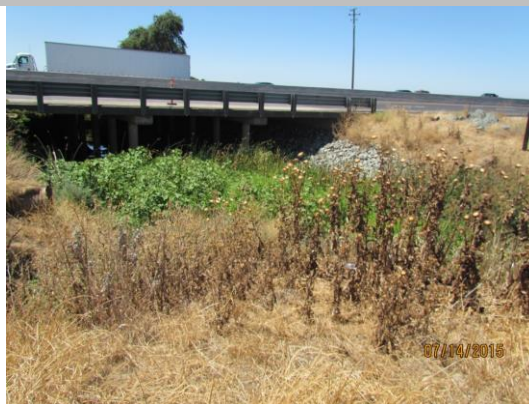
Photo 2 of 2 : CH_2016_NA0017_44_81_20160720_00034.jpg

View of vegetation on the upstream end of the channel.

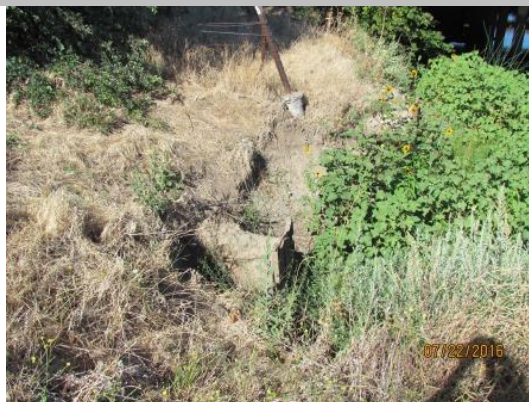
Photo 1 of 2 : CH_2016_NA0017_44_83_20160803_00086.jpg

Rating **	M	Issue No.	83	GPS Lat/Long
Issue Type +	Ma	Location *		37.872077 °
Category	Rivers, Channels & Designated Flood			-121.219318 °
Item	Erosion / Bank Caving			
DWR ID	DWR_NA0017_44_c_2012_83			
Action/Comments				
Inspector Comments: Erosion is present on the bank of the channel.

Updated picture of the erosion on the left bank of the channel looking upstream.

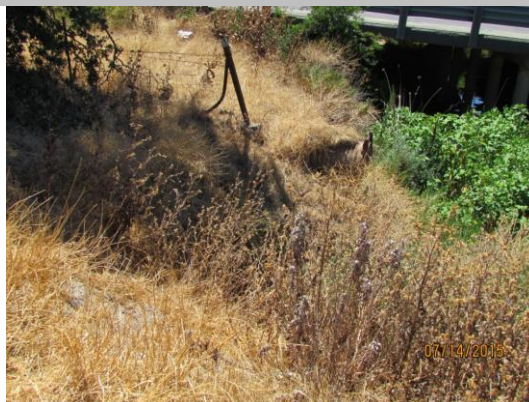
Photo 2 of 2 : CH_2016_NA0017_44_83_20160720_00035.jpg

View of the erosion on the channel bank looking upstream.

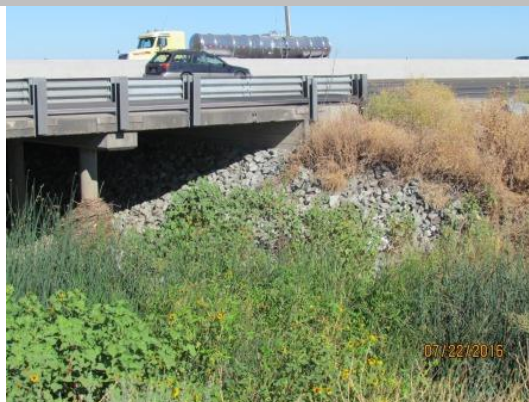
Photo 1 of 1 : CH_2016_NA0017_44_84_20160803_00087.jpg

Rating **	A	Issue No.	84	GPS Lat/Long
Issue Type +	Ma	Location *		37.872077 °
Category	Rivers, Channels & Designated Flood			-121.219318 °
Item	Revetments			
DWR ID	DWR_NA0017_44_c_2012_84			
Action/Comments				
Inspector Comments: Existing revetments were properly maintained at this location.

View of the existing revetments on the upstream end of the channel.

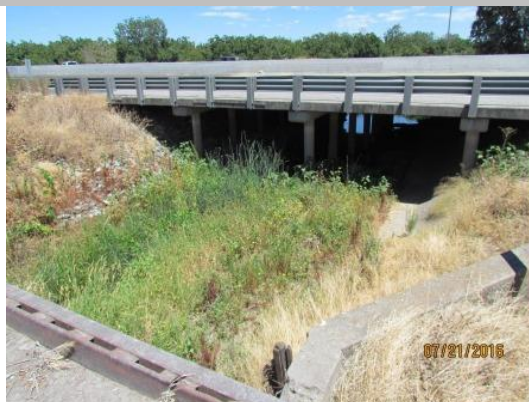
Photo 1 of 2 : CH_2016_NA0017_44_86_20160803_00083.jpg

Rating **	M	Issue No.	86	GPS Lat/Long
Issue Type +	Ma	Location *		37.872077 °
Category	Rivers, Channels & Designated Flood			-121.219318 °
Item	Vegetation & Obstructions			
DWR ID	DWR_NA0017_44_c_2012_86			
Action/Comments				
Inspector Comments: Vegetation may impede the flow of the channel.

View of the vegetation looking downstream of the channel during 2016 inspection.

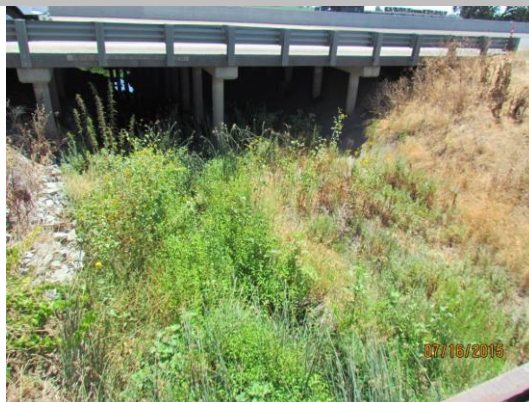
Photo 2 of 2 : CH_2016_NA0017_44_86_20160720_00037.jpg

Rating **	M	Issue No.	86 (cont)	GPS Lat/Long
Issue Type +	Ma	Location *		37.872077 °
Category	Rivers, Channels & Designated Flood			-121.219318 °
Item	Vegetation & Obstructions			
DWR ID	DWR_NA0017_44_c_2012_86			
Action/Comments				
Inspector Comments: Vegetation may impede the flow of the channel.

View of the vegetation looking downstream of the channel.

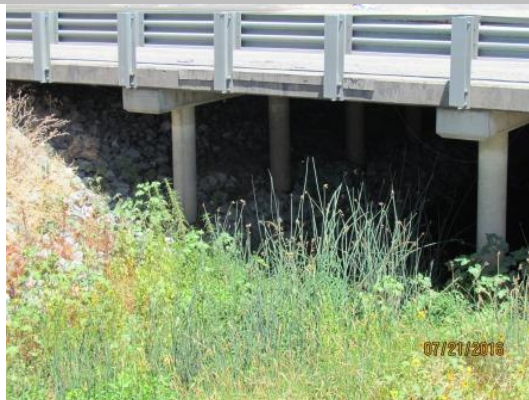
Photo 1 of 1 : CH_2016_NA0017_44_89_20160803_00084.jpg

Rating **	A	Issue No.	89	GPS Lat/Long
Issue Type +	Ma	Location *		37.872077 °
Category	Rivers, Channels & Designated Flood			-121.219318 °
Item	Revetments			
DWR ID	DWR_NA0017_44_c_2012_89			
Action/Comments				
Inspector Comments: Existing riprap was properly maintained at this location.

View of the existing revetments on the downstream of the channel.

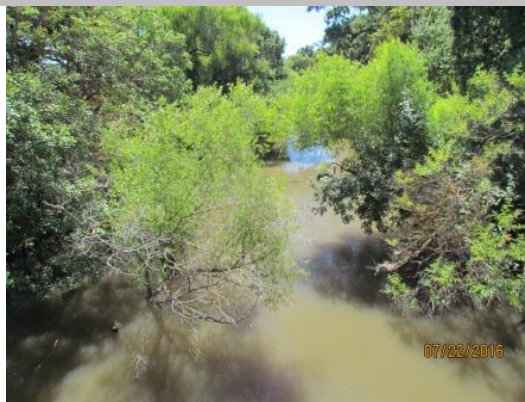
Photo 1 of 1 : CH_2016_NA0017_44_120_20160803_00088.jpg

Inspector Comments: Minimal vegetation may not impede the flow of the channel. Tree branches may fall in the channel in future.

View of the channel looking upstream.

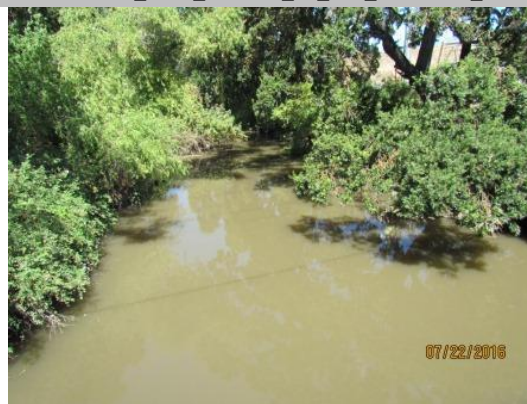
Photo 1 of 1 : CH_2016_NA0017_44_125_20160803_00089.jpg

Inspector Comments: Tree branches may fall into the channel, but the flow is not impeded.

View of the vegetation on the downstream of the channel during 2016 inspection.

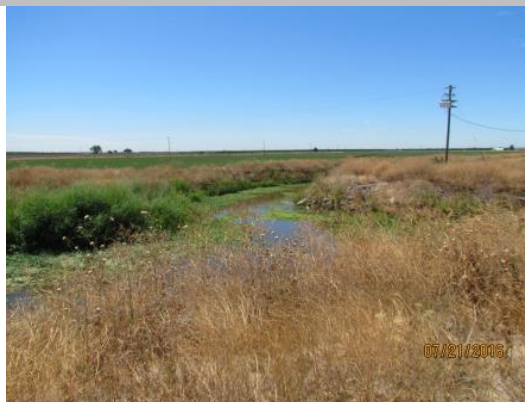
Photo 1 of 1 : CH_2016_NA0017_45_6_20160802_00016.jpg

Rating **	A	Issue No.	6	GPS Lat/Long
Issue Type +	Ma	Location *		37.888860 °
Category	Rivers, Channels & Designated Flood			-121.130320 °
Item	Vegetation & Obstructions			
DWR ID	DWR_NA0017_45_c_2012_6			
Action/Comments				
Inspector Comments: Minimal vegetation was present in the channel but it is unlikely to impede the flow.

View of the confluence looking downstream.

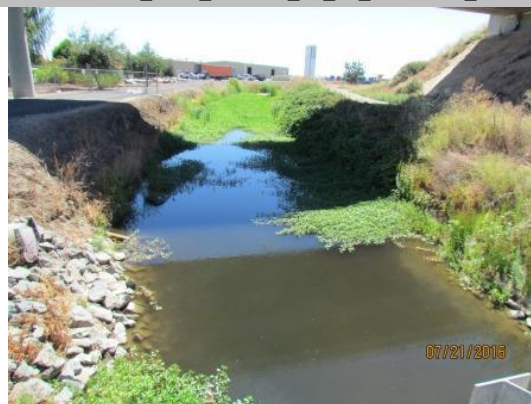
Photo 1 of 2 : CH_2016_NA0017_45_11_20160802_00017.jpg

Inspector Comments: Minimal vegetation growth was found in the channel, but it is unlikely to impede the flow in the channel.

View of the channel looking upstream during 2016 inspection.

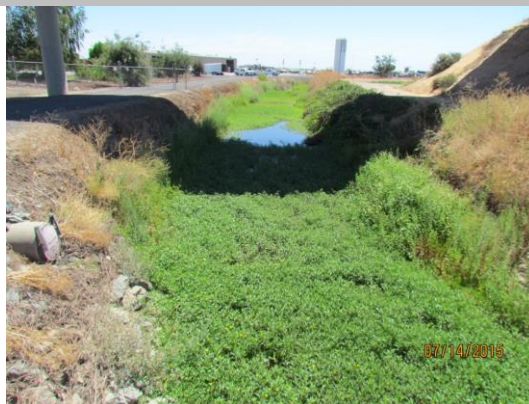
Photo 2 of 2 : CH_2016_NA0017_45_11_20160613_00002.jpg

Inspector Comments: Minimal vegetation growth was found in the channel, but it is unlikely to impede the flow in the channel.

View of the vegetation upstream end of the channel.

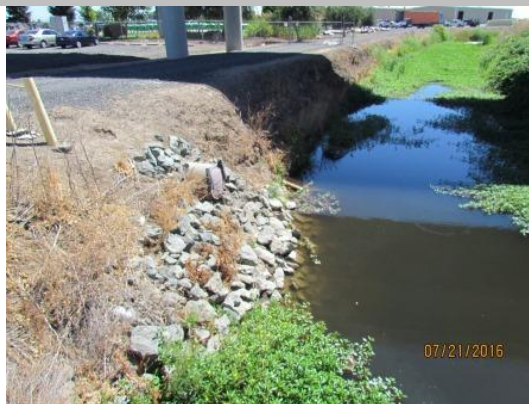
Photo 1 of 1 : CH_2016_NA0017_45_14_20160802_00018.jpg

Inspector Comments: Existing riprap is properly maintained at this location.

View of the existing riprap on the channel bank looking upstream.

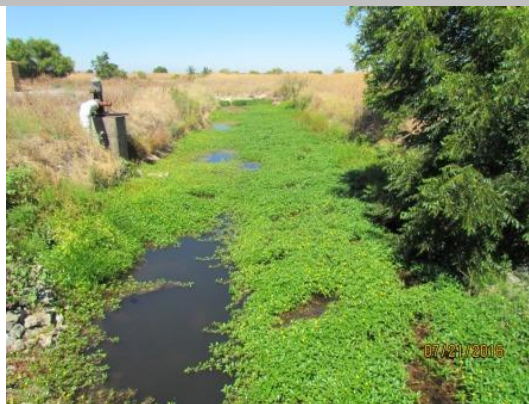
Photo 1 of 1 : CH_2016_NA0017_45_16_20160802_00019.jpg

Rating **	M	Issue No.	16	GPS Lat/Long
Issue Type +	Ma	Location *		37.889520 °
Category	Rivers, Channels & Designated Flood			-121.146980 °
Item	Vegetation & Obstructions			
DWR ID	DWR_NA0017_45_c_2012_16			
Action/Comments				
Inspector Comments: Vegetation growth may obstruct the flow of the channel.

View of the vegetation on the channel looking downstream.

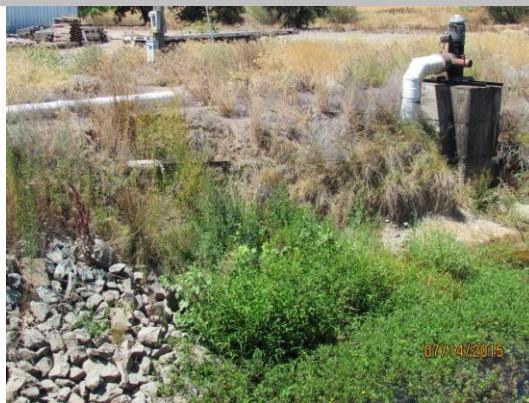
Photo 1 of 1 : CH_2016_NA0017_45_18_20160613_00005.jpg

Rating **	M	Issue No.	18	GPS Lat/Long
Issue Type +	Ma	Location *		37.889520 °
Category	Rivers, Channels & Designated Flood			-121.146980 °
Item	Erosion / Bank Caving			
DWR ID	DWR_NA0017_45_c_2012_18			
Action/Comments				
Inspector Comments: Minor erosion or bank caving is present.

View of bank erosion on the downstream of the channel.

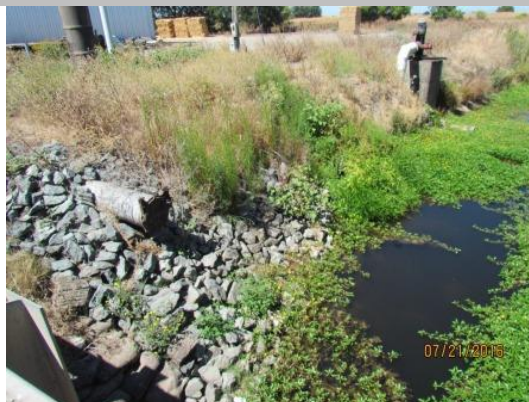
Photo 1 of 1 : CH_2016_NA0017_45_19_20160802_00020.jpg

Rating **	A	Issue No.	19	GPS Lat/Long
Issue Type +	Ma	Location *		37.889520 °
Category	Rivers, Channels & Designated Flood			-121.146980 °
Item	Revetments			
DWR ID	DWR_NA0017_45_c_2012_19			
Action/Comments				
Inspector Comments: Existing revetments appeared to be properly maintained.

View of the existing revetments on the channel bank looking downstream.

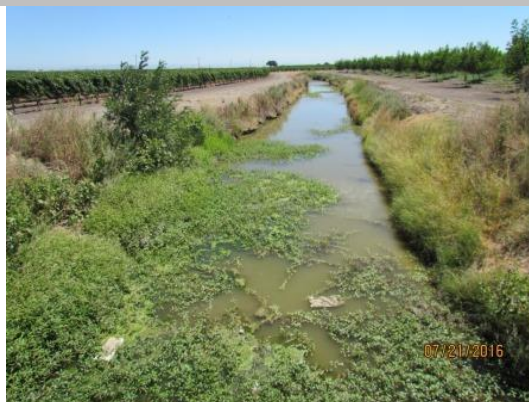
Photo 1 of 2 : CH_2016_NA0017_45_21_20160802_00021.jpg

Rating **	A	Issue No.	21	GPS Lat/Long
Issue Type +	Ma	Location *		37.886056 °
Category	Rivers, Channels & Designated Flood			-121.183664 °
Item	Vegetation & Obstructions			
DWR ID	DWR_NA0017_45_c_2012_21			
Action/Comments

View of the vegetation on the channel looking upstream during 2016 inspection.

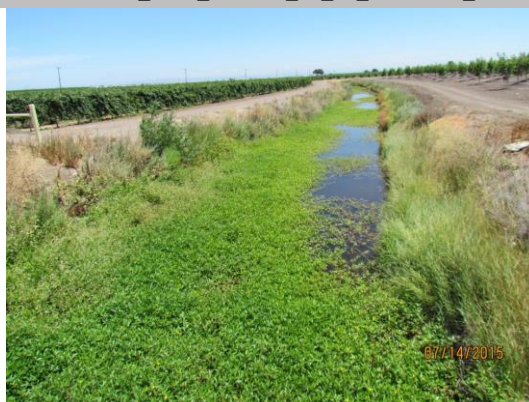
Photo 2 of 2 : CH_2016_NA0017_45_21_20160613_00007.jpg

View of the vegetation on the upstream of the channel.

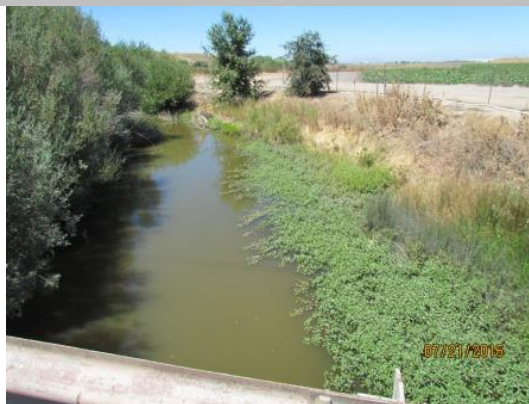
Photo 1 of 1 : CH_2016_NA0017_45_26_20160803_00023.jpg

Rating **	A	Issue No.	26	GPS Lat/Long
Issue Type +	Ma	Location *		37.886056 °
Category	Rivers, Channels & Designated Flood			-121.183664 °
Item	Vegetation & Obstructions			
DWR ID	DWR_NA0017_45_c_2012_26			
Action/Comments				
Inspector Comments: Minimal vegetation was found during the inspection, but the flow is unlikely to be impeded.

View of downstream of the channel.

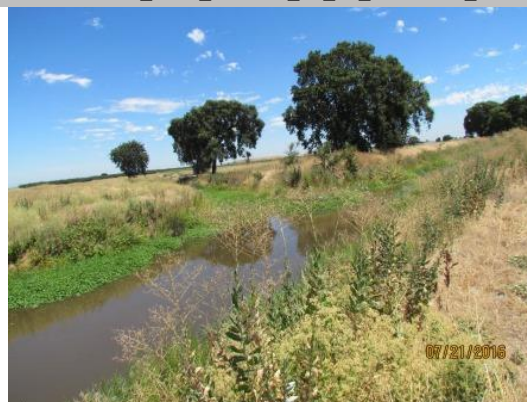
Photo 1 of 1 : CH_2016_NA0017_45_31_20160803_00024.jpg

Check Point / View			
Confluence at Airport Way / Up			
Rating **	A	Issue No.	31
Issue Type +	Ma	Location *	
Category	Rivers, Channels & Designated Flood		GPS Lat/Long
Item	Vegetation & Obstructions		
DWR ID	DWR_NA0017_45_c_2012_31		
Action/Comments			
Inspector Comments: Minimal scattered vegetation is unlikely to impede the flow of the channel.

View of the confluence looking upstream.

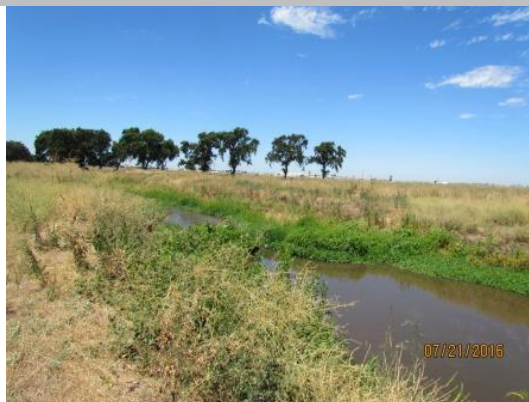
Photo 1 of 1 : CH_2016_NA0017_45_36_20160803_00025.jpg

Inspector Comments: Minimal scattered vegetation is unlikely to impede the flow of the channel.

View of the downstream of the channel during 2016 inspection.

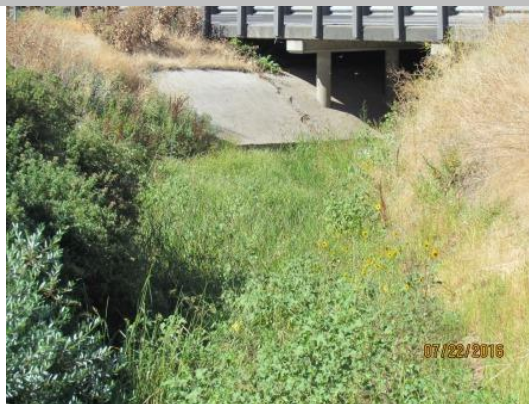
Photo 1 of 1 : CH_2016_NA0017_45_41_20160803_00028.jpg

Rating **	M	Issue No.	41	GPS Lat/Long
Issue Type +	Ma	Location *		37.875127 °
Category	Rivers, Channels & Designated Flood			-121.219201 °
Item	Vegetation & Obstructions			
DWR ID	DWR_NA0017_45_c_2013_41			
Action/Comments				
Inspector Comments: Dense vegetation may impede the flow of the channel.

View of the vegetation on the upstream of the channel.

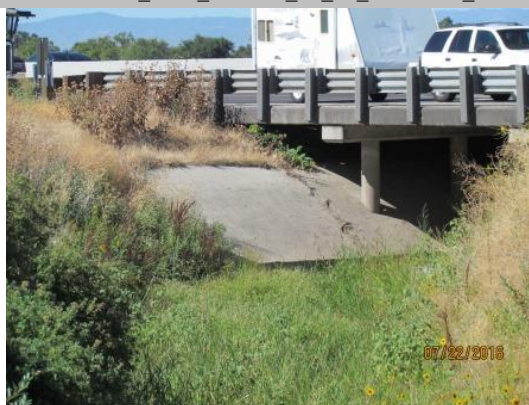
Photo 1 of 1 : CH_2016_NA0017_45_43_20160803_00029.jpg

Rating **	A	Issue No.	43	GPS Lat/Long
Issue Type +	Ma	Location *		37.875127°
Category	Rivers, Channels & Designated Flood			-121.219201°
Item	Revetments			
DWR ID	DWR_NA0017_45_c_2013_43			
Action/Comments				
Inspector Comments: Existing revetments were properly maintained.

View of the existing revetment looking upstream.

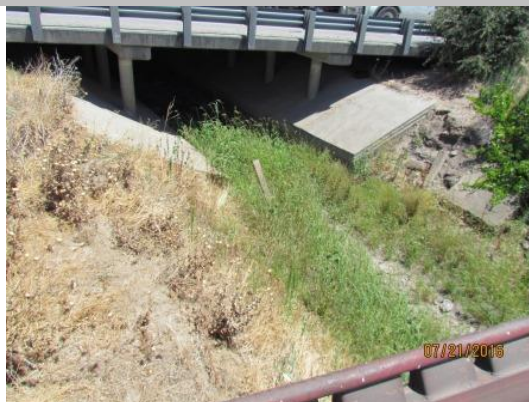
Photo 1 of 1 : CH_2016_NA0017_45_45_20160803_00026.jpg

Rating **	A	Issue No.	45	GPS Lat/Long
Issue Type +	Ma	Location *		37.875127 °
Category	Rivers, Channels & Designated Flood			-121.219201 °
Item	Vegetation & Obstructions			
DWR ID	DWR_NA0017_45_c _ 2013_45			
Action/Comments				
Inspector Comments: Vegetation was not imepeding the flow of the channel.

View of the channel looking downstream.

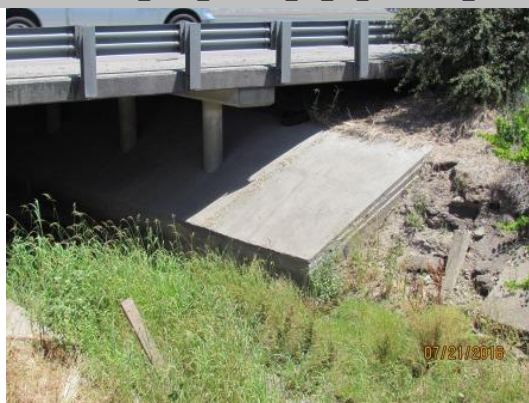
Photo 1 of 1 : CH_2016_NA0017_45_48_20160803_00027.jpg

Rating **	A	Issue No.	48	GPS Lat/Long
Issue Type +	Ma	Location *		37.875127 °
Category	Rivers, Channels & Designated Flood			-121.219201 °
Item	Revetments			
DWR ID	DWR_NA0017_45_c_2013_48			
Action/Comments				
Inspector Comments: Existing revetments were properly maintained.

View of the revetments on the downstream of the channel.
